A9 Berriedale Braes Improvement Geotechnical, Design and Construction Assessment

July 2011

Geotechnical, Design and Construction Assessment July 2011

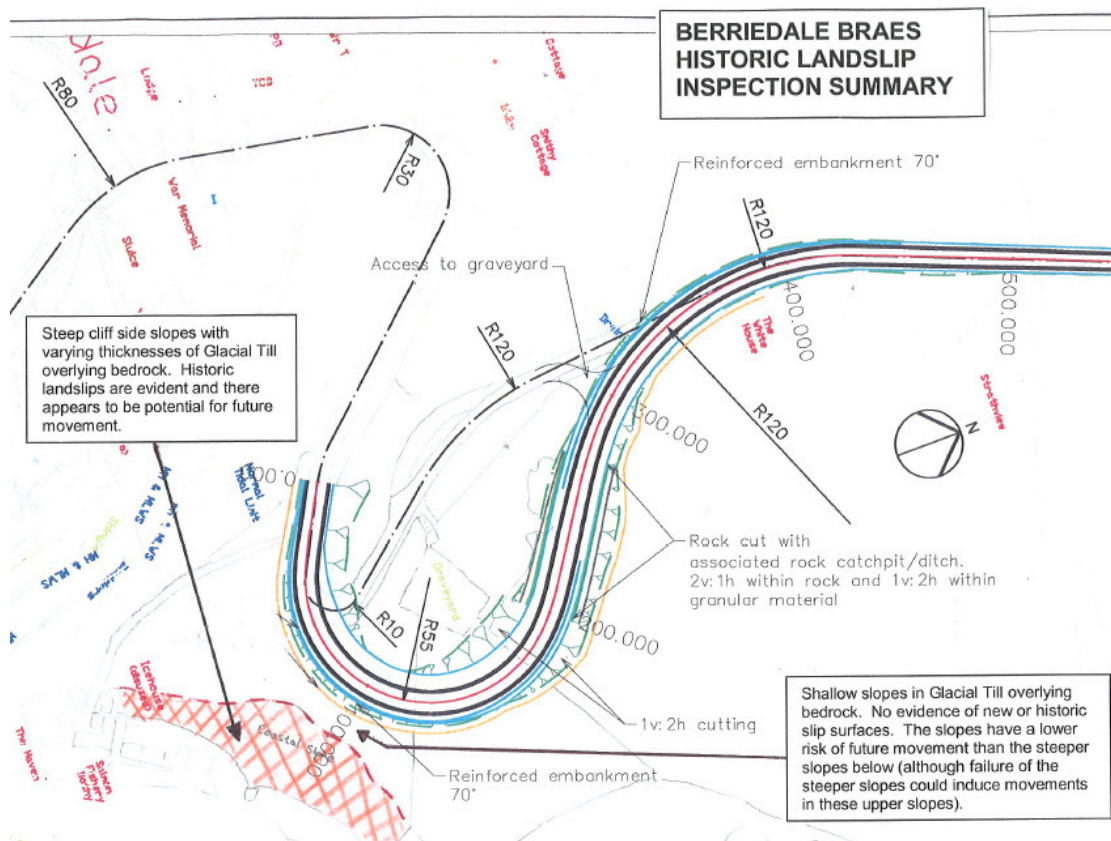
Figure 5.1 Historic Landslip Inspection Summary

This part of the site lies on land that slopes towards the coast. There are no cliffs at the toe of the slope and the potential for historic landslips has been noted in the Wellbeck report and the Scottish Natural Heritage information. An engineering inspection was undertaken to assess the condition of the existing cliff-side slopes and determine the potential for future movements. Figure 5.1 (see below) summarises the findings of the inspection.

Furthest from the re-alignment there are the steep cliff-side slopes which are highlighted on Figure 5.1 as red hatching. The OS mapping notes the area as 'Coastal Slopes'. These slopes appear to have been shaped by historic slip failures as the Glacial till, sitting on the bedrock at a steeper profile than its effective angle of repose can sustain, has slipped down towards the shoreline. The recent slope inspection found rabbit burrows, bare soil scars, very damp soil and hydrophilic vegetation, all indicators of potential for future slope instability. There was no recent spoil evident along the shoreline at the toe of the slope.

line with the unroofed structure, there is a step in the slope of approx 0.5m high that follows the contours round to the hairpin bend, a levelled out area looking like an old access runs on this stepped area. If this is not a man made feature then it may be a relic back-scar and the bowl-like shape may be indicative of past slope movement.

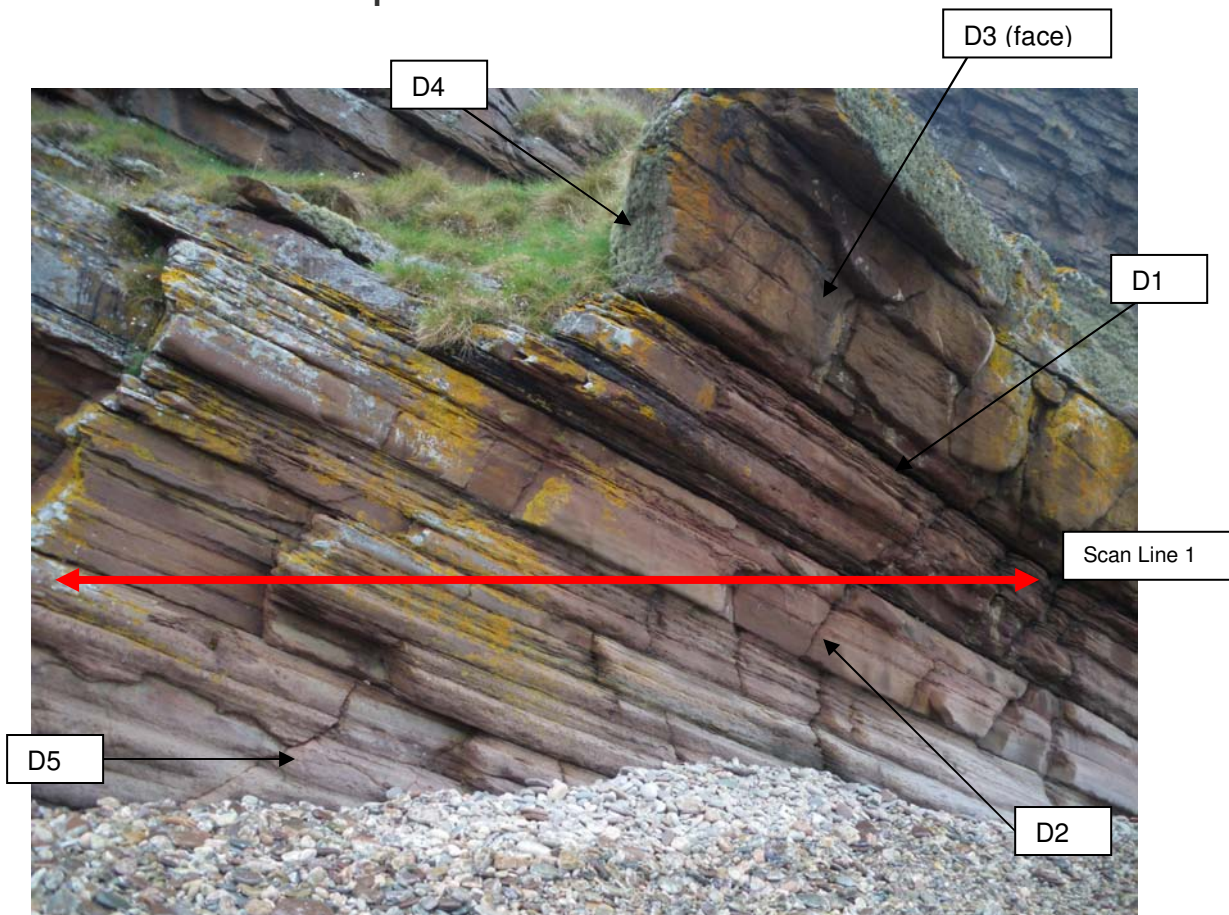
Scan Line 1

D4 and D5 are a conjugate joint set.

The rock is dry and seepage is not visible at any surface.

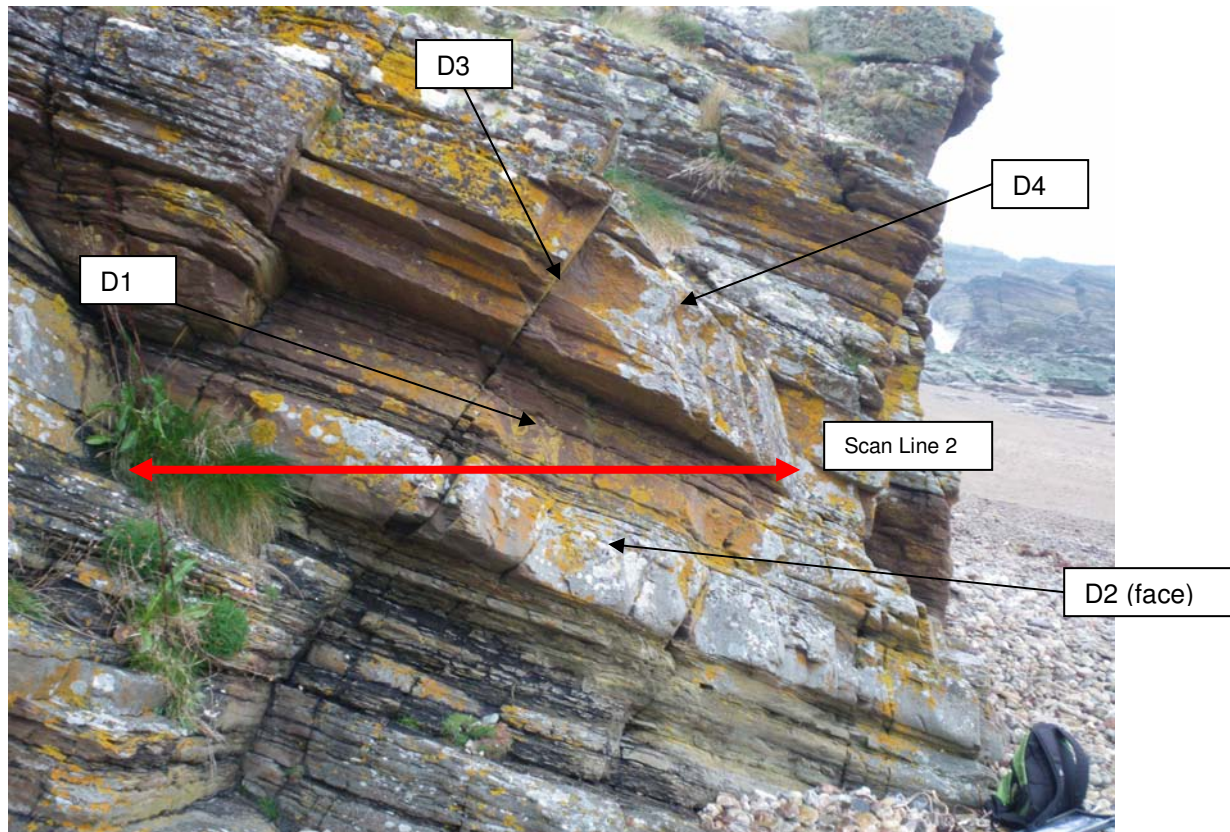
Scan Line 2

D1 is the bedding. The bedding spacing is 60mm to 0.6m with moderately wide to wide rough planar discontinuity apertures containing some surface staining and disintegrated rock. The bedding is orientated at 22/120 to 25/130. The bedding is the dominant and most persistent discontinuity.

D3 on this face is a medium to wide spaced smooth planar joint with a dip of 60° just west of north and is tight to moderately wide in-filled with disintegrated rock when moderately wide and clean or surface staining when tight. D3 forms the face of the rock blocks on Scan line 1. D2 on scan line 1 forms the block faces, D2, on this scan line.

A third wide spaced joint, D4, is recorded with a dip of 70° to the south west with partly open to moderately wide clean smooth planar surfaces.

The rock is dry and seepage is not visible at any surface.

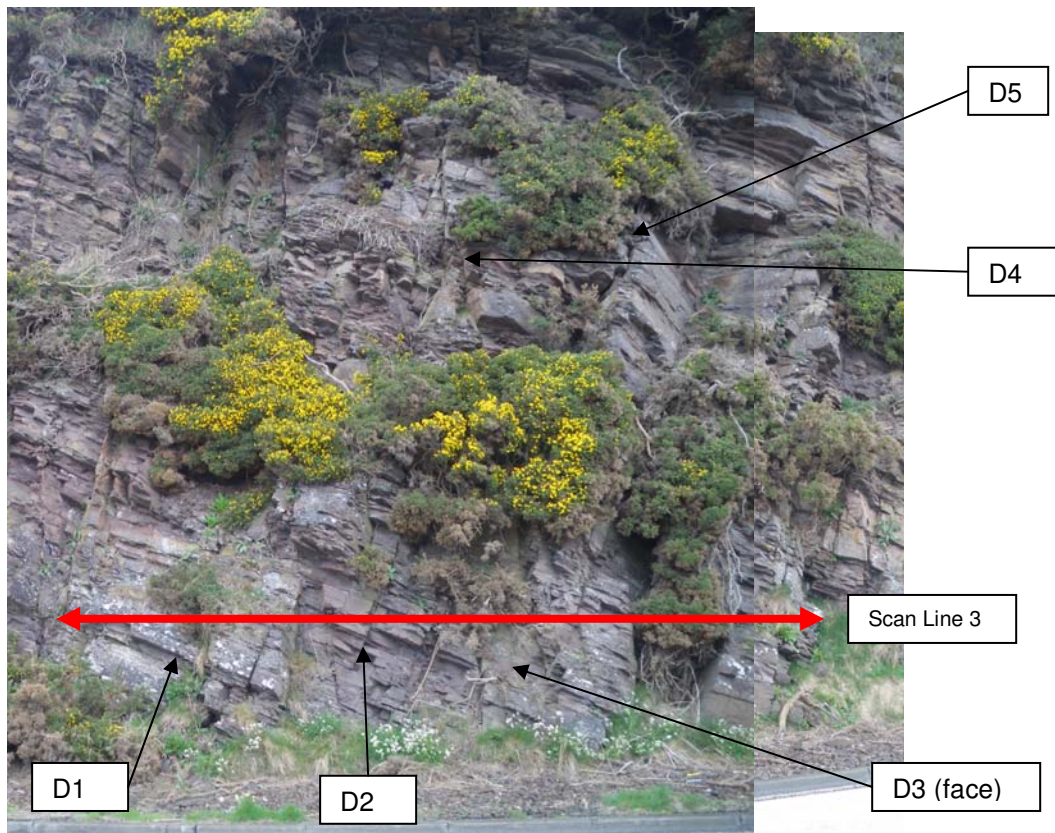
Scan Line 3

On this face 40mm diameter drill holes were noted at approx 1m intervals.

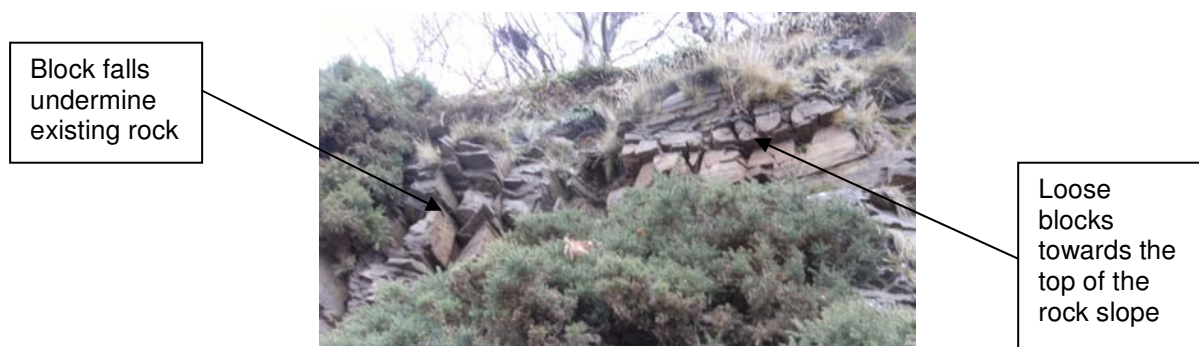
Photo 7.1 Weathered rock and loose rock blocks on roadside rock cut

- The more weathered rock at the top of the cutting is very fragmented and small to medium blocks look ready to fall (see photo 7.1).

- Evidence of small scale rock falls as lower blocks fall off the face leaving overlying blocks unstable and at risk of failure.
- Minor wedge failures and are apparent on the roadside rock cut face, with occasional small to medium sized prismatic blocks present in the verge.
- The gorse on the rock face appears to be increasing the potential for failures as the roots force the joints further open.
- Blast damage may be the cause of some rock shattering, and this should be considered at detailed design stage.
- The rock faces are standing at near vertical inclinations but the face alongside the A9 falls slightly back away from the road whereas the shoreline cliffs have a slight overhang.

Although the risks of the three main failure mechanisms were found to be low, this should be confirmed at detailed design stage by further detailed inspection of exposed rock faces in the area in conjunction with assessment of core logs and down hole geophysical results at the rock cut location. The more detailed work will also confirm any requirements for rock slope treatments (rock netting/bolting etc) and /or rock ditches. Land take and geometry of the re-alignment will be affected by the presence of rock trap ditches.

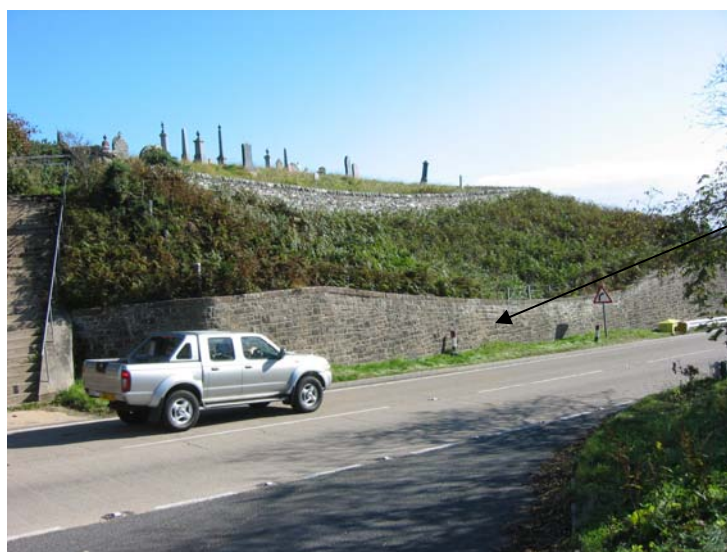
Photo 7.2 Cemetery and retaining wall at the 'Local Widening' location

To improve the road geometry at the bend by locally widening the road would mean demolition of the existing wall (see photo 7.2) and construction of a new wall or reinforced steep slope further north towards the cemetery. Simply trimming the existing slope to a steeper angle would not be possible as the angle of shearing resistance of between 29° and 38° limits a stable slope profile to 1v:2h, which would not provide sufficient space for widening at road level.

Existing retaining wall to be demolished and either re-built further back towards cemetery or replaced by a steep slope to allow widening of the carriageway.

Further ground investigation is required to obtain details of rockhead profile and the properties of the backfill to the retaining wall. A detailed topographical survey from the A9 to the cemetery and the immediate vicinity would also be essential as there is currently no topographic information for this area.
